UV-C Degradation of Plastics: Comparison of ElectroClave LEDs versus Low-Pressure Mercury Lamp

Abstract

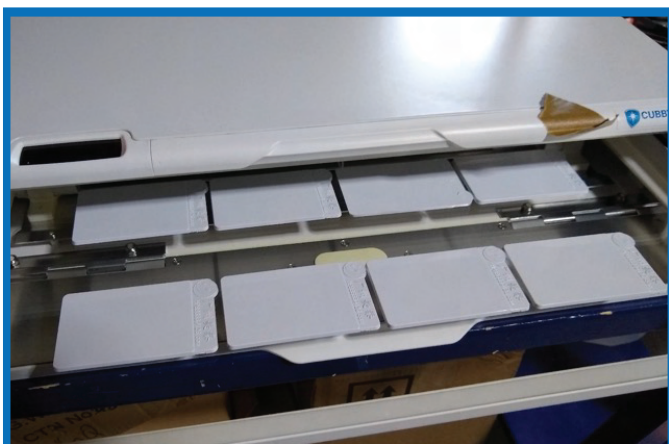
Visual Inspection (Figure 1)

*Figure 1: Fresh (no UV exposure)
ABS plaques*

Visual Inspection: Polymers occasionally exhibit discoloration upon UV degradation. The testing engineer will take pictures using the same camera under identical lighting before and after UV exposure.

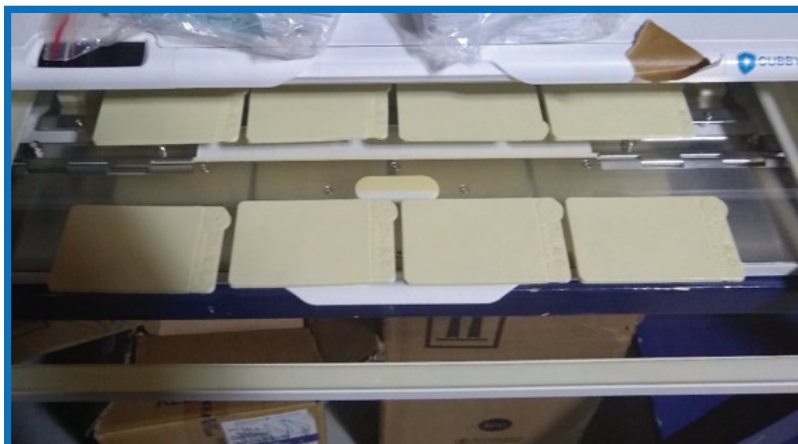
(Figure 2)

Visually, the samples exposed to the UV-C light from the LPMLs were substantially yellowed and darkened. This initial detail immediately confirms material degradation on its own.

*Figure 2: Yellowed ABS Plaques after
UV exposure for three days*
